RM RILEY

MAINTENANCE NOTES

MAINTENANCE AND REPAIR OF ENGINE BEARINGS

ENGINE BEARINGS

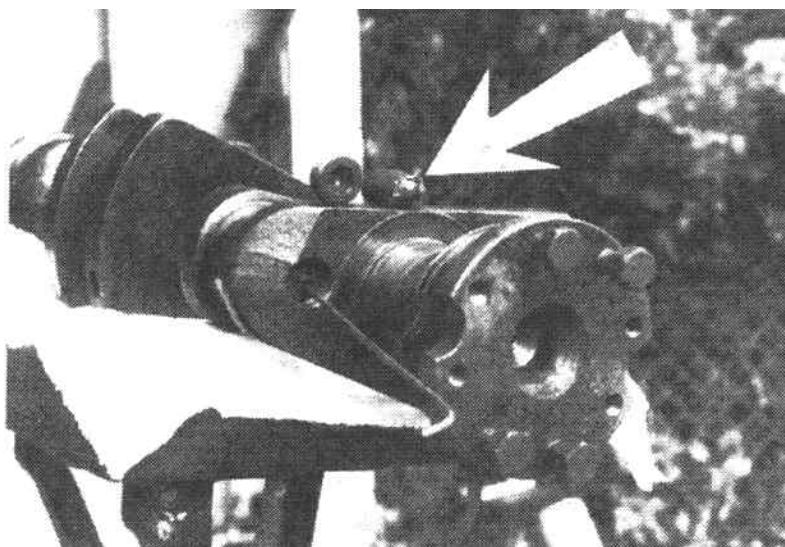
Remove the blanking plugs from the crankshaft big end oil ways and scrape out the accumulation of hardened oil sludge. It is often impossible to unscrew these plugs as they seem to self tighten in service. It is often necessary to drill them out. Access to the plugs in No.2 and No.3 big ends can be improved by knocking out the plug in the counter balance to No. 1 and No.4 big ends. It is safest to drill out the plugs progressively using drills of increasing size until the remains of the threads can be picked out from the crankshaft threads. The need to remove these plugs cannot be over stressed as it is impossible to clean the crankshaft properly with them in position. When the crankshaft is rotating, the sludge in the oil is centrifuged out and remains in the big end oilways. It continues to be centrifuged and slowly compacts so hard that it usually has to be chipped out. Simply washing the crankshaft in a degreasing fluid and trying to poke the oilway clean is not sufficient. **These plugs must be removed no matter how difficult this may be.**

Figure 16. Resting on this 2½ litre crankshaft is a big end blanking plug. Next to it is a slug which has been removed from a big end oil way. The slug of sludge remaining in No.4 oil way is thick enough to support a long welding rod.

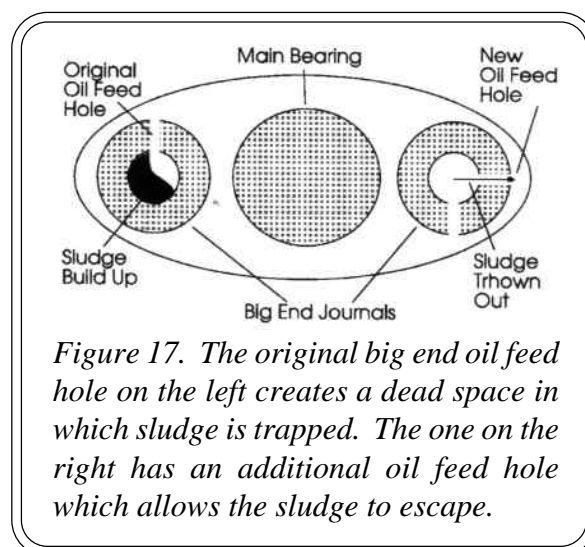
The feed hole from the oilway in the big end to the bearing surface is not radially outward from the crankshaft centre line nor is it of generous size. The result is a dead space inside the big end oil way into which the heavier particles in the oil are thrown by the rotation of the

Figure 17. The original big end oil feed hole on the left creates a dead space in which sludge is trapped. The one on the right has an additional oil feed hole which allows the sludge to escape.

crankshaft. These accumulate in the dead space gradually filling it. Eventually the dead space is filled and the heavy particles start to build up in the space through which the oil is trying to flow. Finally the space is completely filled and the oil can no longer reach the bearing surface.

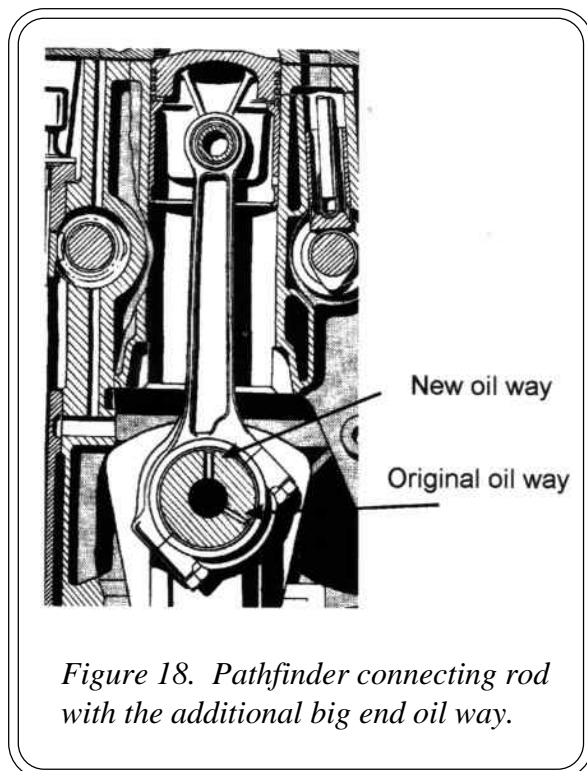
Figure 18. Pathfinder connecting rod with the additional big end oil way.
