Piston rings

Sealing under extreme conditions

PRODUCT
INFORMATION

Function and design

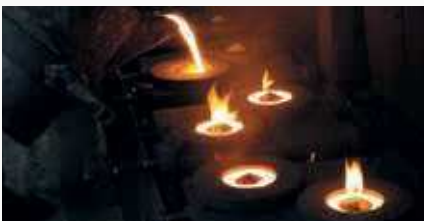
Casting process for piston ring castings (die casting)

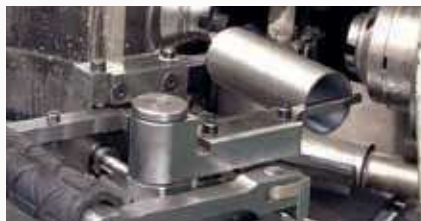
Grinding the piston ring sliding surface

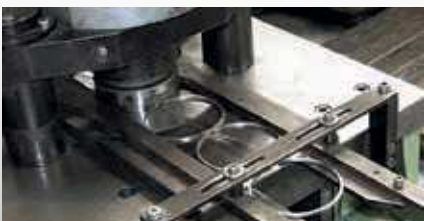
Internal lathe – manufacturing the inner contours

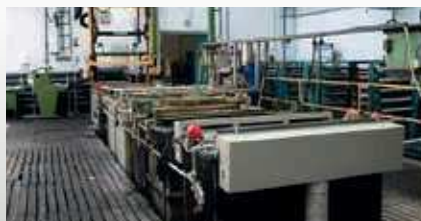
Phosphate coating plant

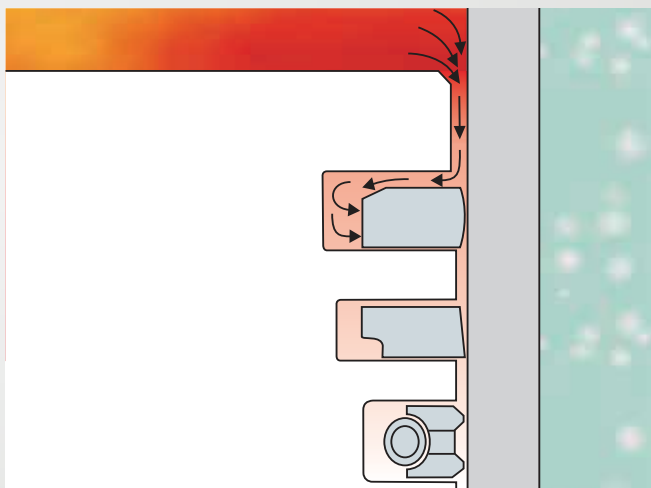
Continuous heat dissipation

Temperature management is a vital task of the piston rings. Most of the heat that is absorbed by the piston during the combustion process is dissipated by the piston rings to the cylinder. Without this continuous heat dissipation, the aluminium piston would melt within minutes.

Compression rings dissipate up to 70% of the piston temperature to the engine block.

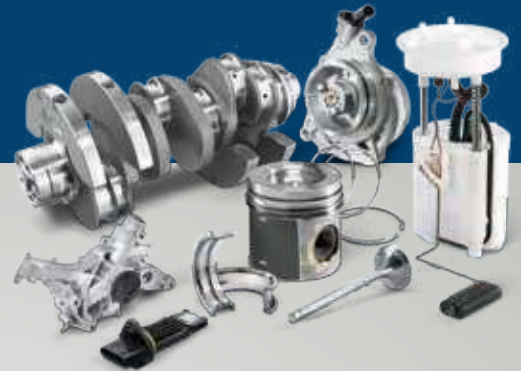
Two are better than one

Two scraping lands on oil control rings ensure that the oil film thickness of 1 – 2 μm required for lubrication is always achieved, but never exceeded. Low oil consumption and mixture flow rate, as well as a long service life of the associated parts, are implemented in a virtually ideal manner.

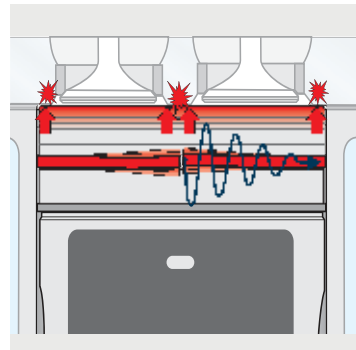
Piston impact on the cylinder head

If the sealing area of an engine block is reconditioned and a piston with standard compression height fitted, this may cause mechanical impact by the piston on the cylinder head in the case of diesel engines. The same occurs if cylinder head gaskets with the wrong thickness are fitted. Due to these hard impacts, the piston rings start to flutter and no longer seal properly.

Consequence: High oil consumption and high cylinder wear (see also "Fuel flooding")

Remedy: Compliance with the correct piston protrusion, use of the correct cylinder head gaskets
